# The Cherry Hinton Brook

## A. Hydrology and over-abstraction

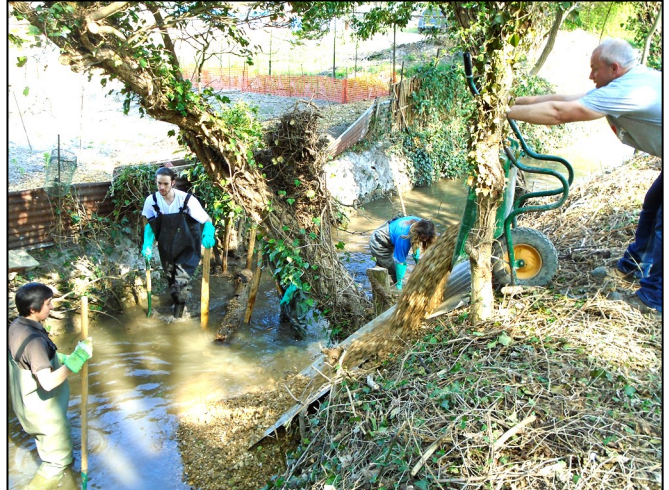
Along with most of the River Cam's tributaries the Cherry Hinton Brook suffered canalisation. This was a process, supposedly to reduce the risk of flooding which fell out of fashion by about the 1980s. The result is illustrated in the photo below which was taken along Snakey Path where the stream skirts the three Cherry Hinton Lakes. Typically, the channel was

straightened and deepened and the sides of the channel were steepened with the result that the channel was widened. So, every last vestige of the original Chalk stream channel was destroyed.

In recent years much effort has been put into 'channel restoration' along Daws Lane (photo above, 2021) and Snakey Path by shovelling in many tons of flint gravel. However it does raise the question, 'What is being restored?' The beds of Chalk stream channels elsewhere in England typically consist of flint gravel but judging by the spoil levée in the photo (below, left) there was no gravel here. Presumably the bed of this

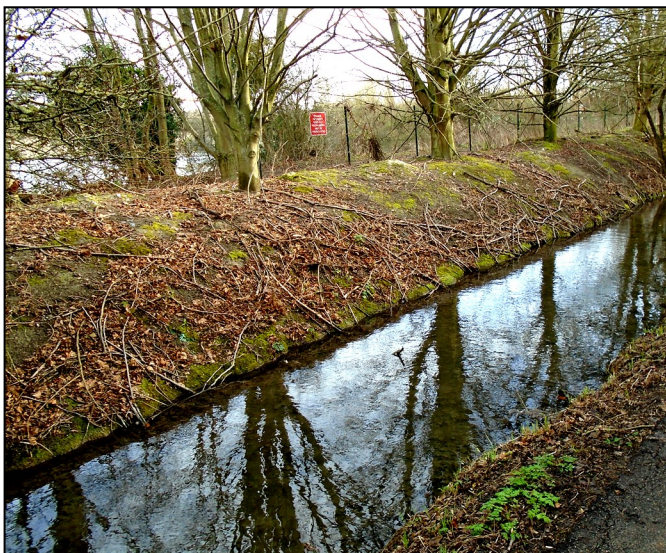
One of the Lakes is just visible in the photo on the left. These flooded quarries are, in themselves, an abuse of landscape on a heavy industrial scale, having provided clayey Chalk for the adjacent cement works (see photo above) which served the citizenry's demands at the time. The works were demolished in 1988 but are shown in the 1981 photo above taken from near the Daws Lane allotments with the overgrown Brook channel in the foreground. In 1950s, within living memory, waste from the works was discharged into

the Brook causing it to flow sludgy grey.

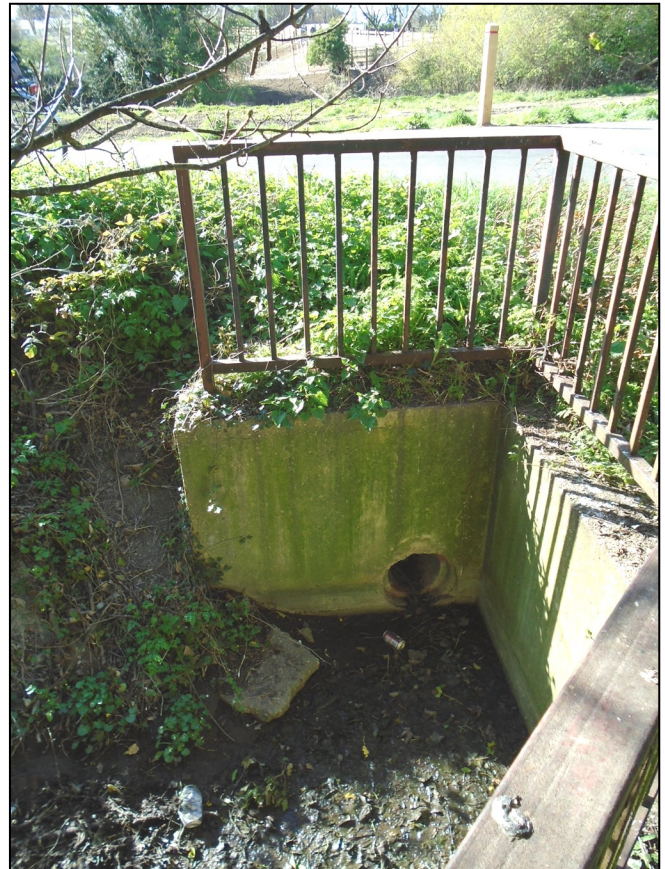
The photo above right shows where, in effect, the Cherry Hinton Brook terminates, nearby at (e).

The channel of Coldhams Brook also therefore ends here, ignominiously, without quite reaching the Newmarket Road. In the 16th century the Brook continued in its alignment, crossed the road and supplied a paper mill (a precursor of CUP) with water. If the flowing water of the Brook should ever reach (e) nowadays it would have to enter the pipe in the photo (shown as dashed line ef on map) and to flow down the slope into the East Main Drain flowing from left to right in the shallow valley near the top of the photo. There is no escape. Coldhams Brook and the Cherry Hinton Brook cannot reach the River Cam undefiled. All of their combined waters enter the East Main Drain sooner or later.
